Long-Term Post-Fire Hydrologic Impacts & Recovery Needs

Fire Water Nexus

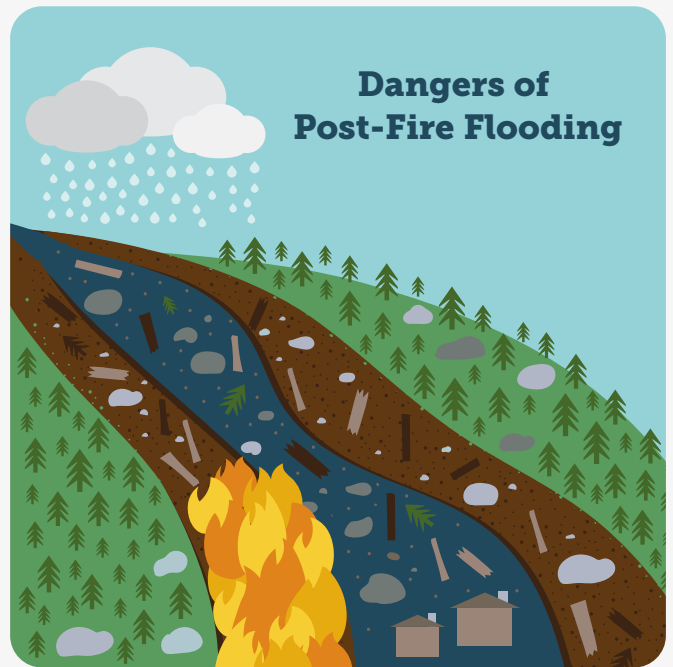
Fires strip trees & vegetation from hillsides.

Fire-scorched soils become hydrophobic soil (a temporarily impermeable soil layer), which cannot absorb rainwater.

Without vegetation or stable soil, debris such as burned trees, soil and ash flow downhill during rain events.

Communities downstream from these flows are at serious risk for flooding.

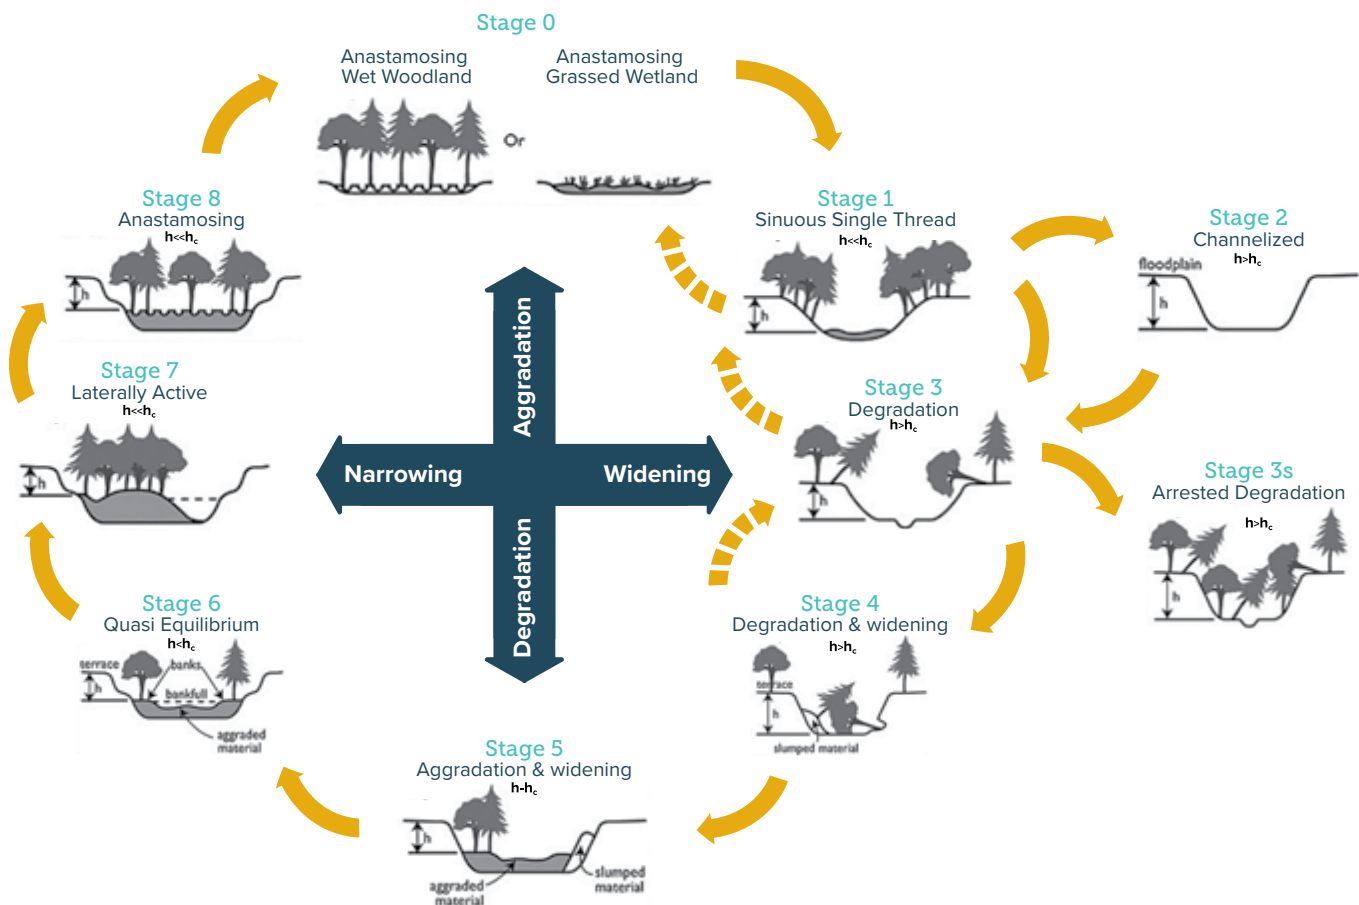
Following the Stream Evolution Model below, Big Cottonwood Creek, in various reaches, was a well-connected floodplain with a laterally active channel and beaver ponds. For the most part, reaches ranged from 6 to 7, with limited sections of 8 and 1. Post-fire flooding carved large incisions into the creek and quickly changed this creek to 2, 3, and narrow areas of 4s. While stream evolution from this current degraded stage may essentially return to pre-flood conditions, this

Cluer, B. and Thorne, C., 2014. A stream evolution model integrating habitat and ecosystem benefits. *River Research and Applications*, 30(2): 135-154. DOI: 10.1002/rra.2631

may take hundreds, possibly thousands of years. During this time, post-fire degraded systems would continue to suffer from the impairments. However, targeted restoration techniques that aim to accelerate stream evolution could assist the recovery process with cost-effective, low-impact (i.e., no heavy equipment necessary) techniques. One such opportunity for restoration is Process-Based Restoration (PBR), as outlined in Wheaton et al. (2019).

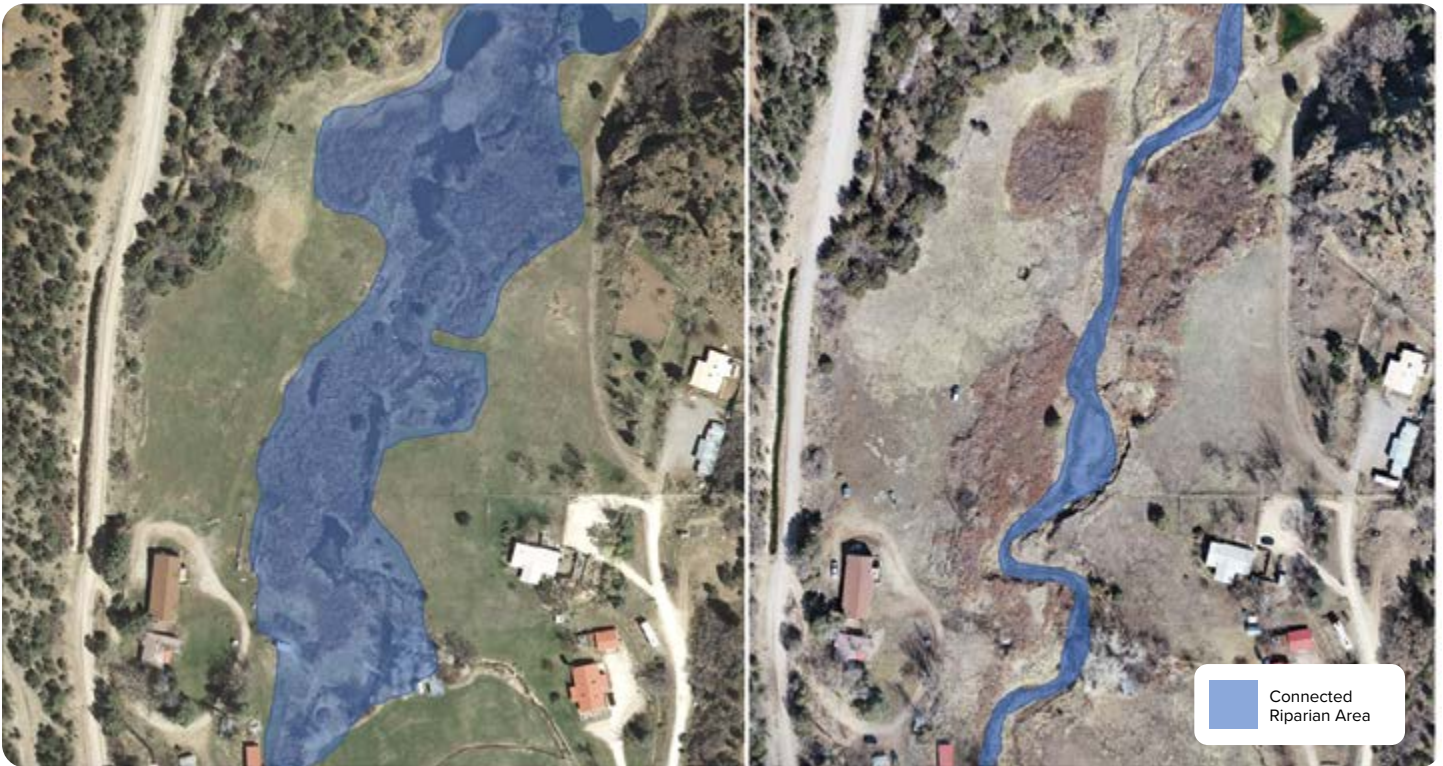
Big Cottonwood Drainage in Fremont County is moving into its 6th-year post-fire, yet many issues remain. The pre-fire stream footprint for this creek was approximately 11 acres. Today, the stream footprint is about 6 acres, primarily due to incisions from post-fire flooding.

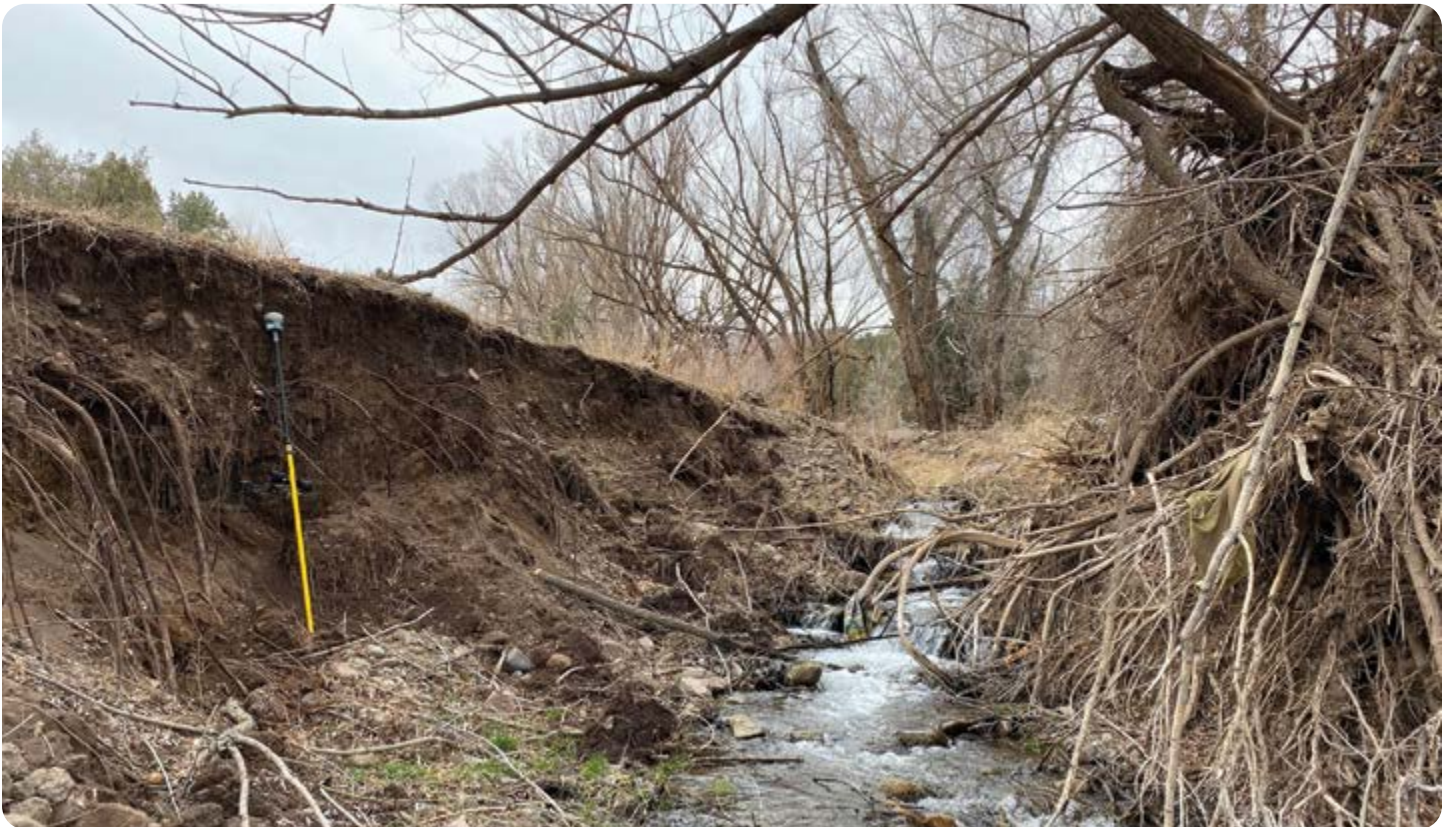
A typical degraded reach on Big Cottonwood Creek.
